## Contents

Compactors – also known as steamrollers – are mobile vehicles used to increase the density of soil and roadways and to seal and smooth asphalt surfaces. Compactors tend to overturn during some operations, thus putting their operators at risk. A rollover protective structure (ROPS) is a part of a compactor or other heavy equipment designed to protect an operator from a crushing injury in the event of a rollover. Particularly with seatbelt use, ROPSs have been shown to save lives.

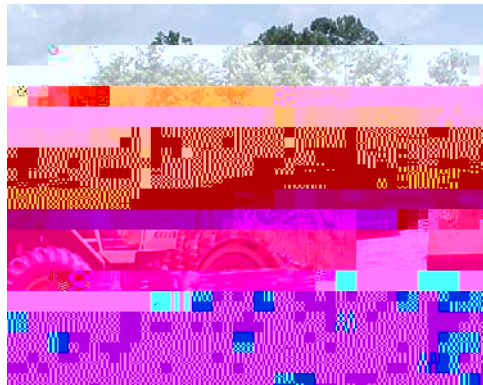
**Figure 2.** A pad-foot compactor with a single drum and articulated steering.

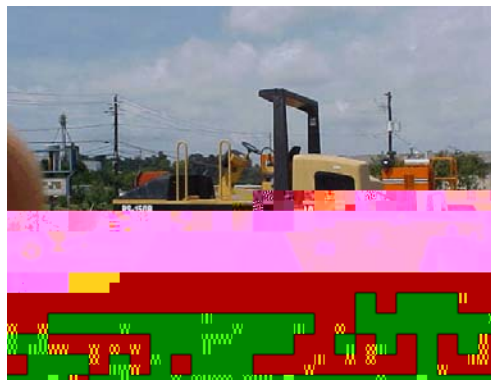
**Figure 3.** A rubber-tired compactor with a two-post ROPS.
